NATIONAL REGISTER OF HISTORIC PLACES INVENTORY -- NOMINATION FORM

SEE INSTRUCTIONS IN HOW	TO COMPLETE NATIONA COMPLETE APPLICABL		S	
1 NAME	COMPLETE APPLICABL	E SECTIONS		
HISTORIC				
Pilgrim Holiness Church				
"Baled Hay Church"		(AT01-1)		
2 LOCATION				
Constant				
STREET & NUMBER		NOT FOR BURLIOATION		
CITY, TOWN		NOT FOR PUBLICATION CONGRESSIONAL DISTR	ICT	
Arthur	_ VICINITY OF	Third		
STATE	CODE	COUNTY	CODE	
Nohraska	31	Arthur	005	
CLASSIFICATION				
CATEGORY OWNERSHIP	STATUS	PRES	ENT USE	
DISTRICTPUBLIC	XOCCUPIED	AGRICULTURE	XMUSEUM	
XBUILDING(S) XPRIVATE	UNOCCUPIED	COMMERCIAL	PARK	
STRUCTUREBOTH	WORK IN PROGRESS	EDUCATIONAL	PRIVATE RESIDENC	
SITE PUBLIC ACQUISITION	ACCESSIBLE	ENTERTAINMENT	RELIGIOUS	
OBJECTIN PROCESS	XYES: RESTRICTED	GOVERNMENT	SCIENTIFIC	
BEING CONSIDERED	YES: UNRESTRICTED	INDUSTRIAL	_TRANSPORTATION	
	NO	MILITARY	OTHER:	
4 OWNER OF PROPERTY				
SECONOMIA CONTRACTOR C				
NAME Arthur County Historical Societ	- 37			
STREET & NUMBER	y			
CITY, TOWN	FIRST Street Control of the Control	STATE

DESCRIBE THE PRESENT AND ORIGINAL (IF KNOWN) PHYSICAL APPEARANCE

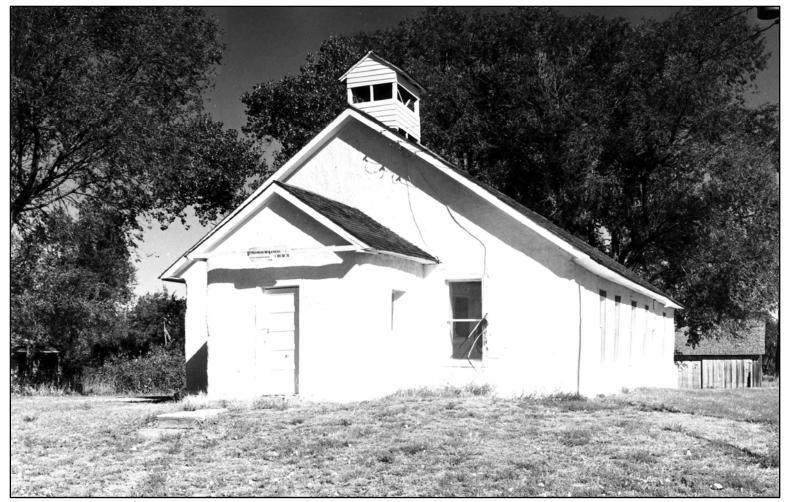
Photo 1 — south & east facades Photo by Janet Jeffries Spencer, 1978, NSHS (7809/8:24)

The Pilgrim Holiness Church at Arthur, Nebraska is a unique church structure built in 1928 of baled rye straw. The simple rectangular building is one-and-one-half stories in height and measures 9.65m by 17m (32 x 56 feet). The walls, which are 60cm (2 feet) thick, are made of rye straw bales which have been stuccoed on the outside and plastered on the inside (see photo #7). A small vestibule protrudes from the front or south facade of the church.

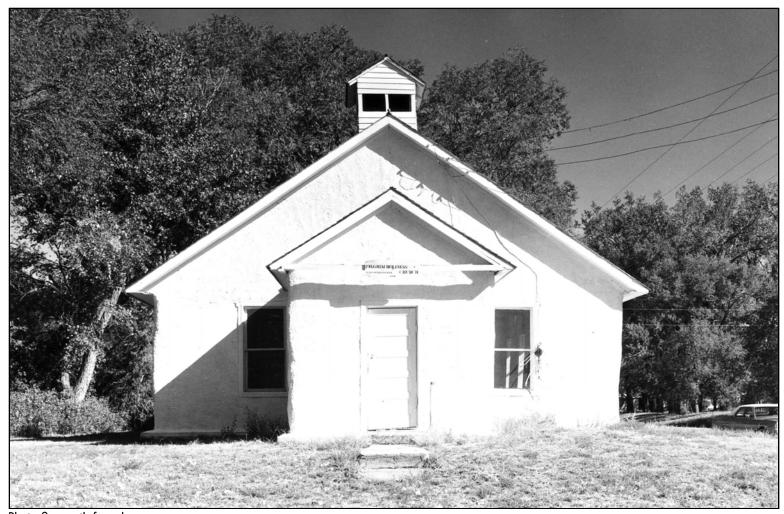
Photo 2 – south facade Photo by Janet Jeffries Spencer, 1978, NSHS (7809/8:21)

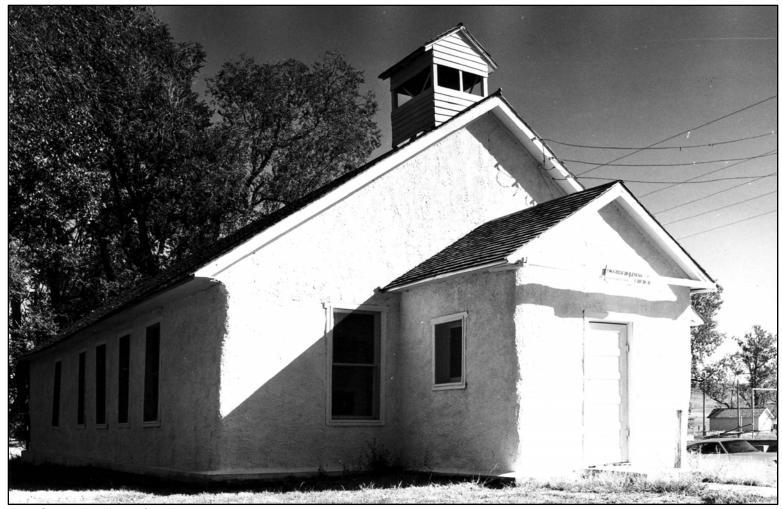
Photo 3 – south and west facades Photo by Janet Jeffries Spencer, 1978, NSHS (7809/8:19)

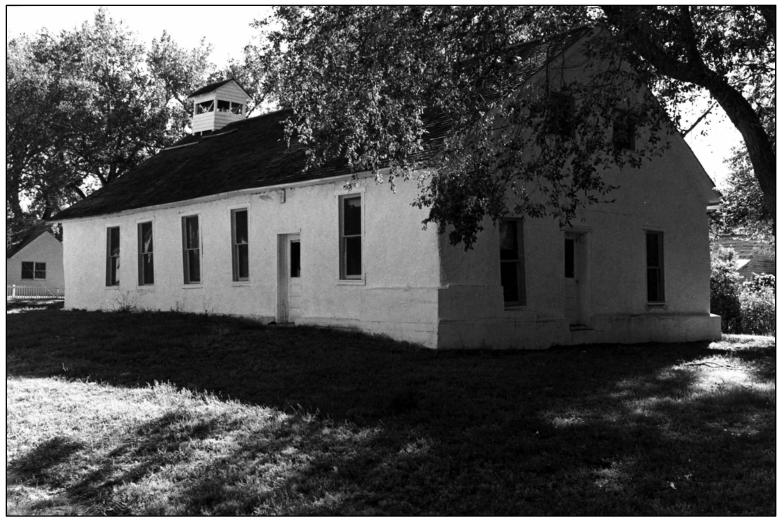
Photo 4 – north and east facades Photo by Janet Jeffries Spencer, 1978, NSHS (7809/9:20)

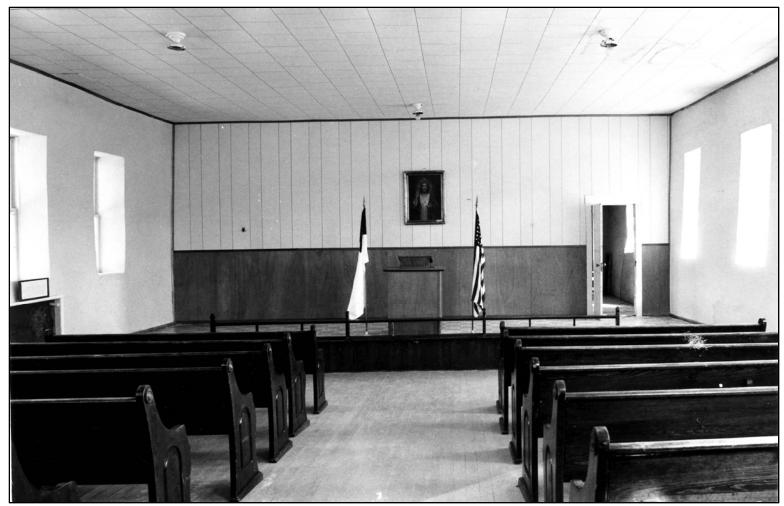
Photo 5 — interior looking north Photo by Janet Jeffries Spencer, 1978, NSHS (7809/8:34)

The interior of the church is simply furnished with seven rows of pews situated on a floor which slopes downward to the altar-platform (see photo #5). Behind the platform are two small rooms, one of which is a kitchen, the other a parlor. An enclosed stairway rises from the kitchen to two sleeping rooms above. According to local informant Joe Monhart, the rear part of the building served as the pastor's residence. Regular services are no longer held in the church which has attracted visitors from all over the world.

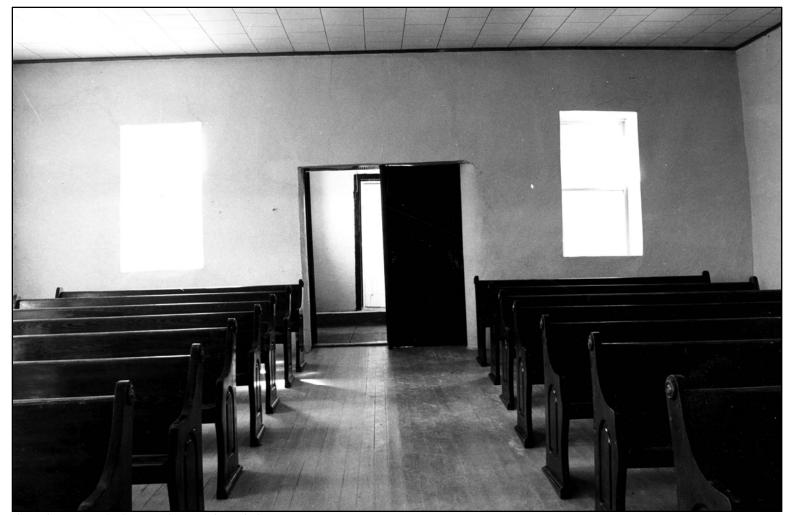
Photo 6 – interior looking south toward vestibule Photo by Janet Jeffries Spencer, 1978, NSHS (7809/8:37)
